TRAINING PAYS OFF IN TWO PENNSYLVANIA HOSPITAL FIRES

JAMES K. LATHROP

ALLEGHENY GENERAL HOSPITAL FIRE April 10, 1977

ST. JOSEPH'S HOSPITAL FIRE
August 10, 1977

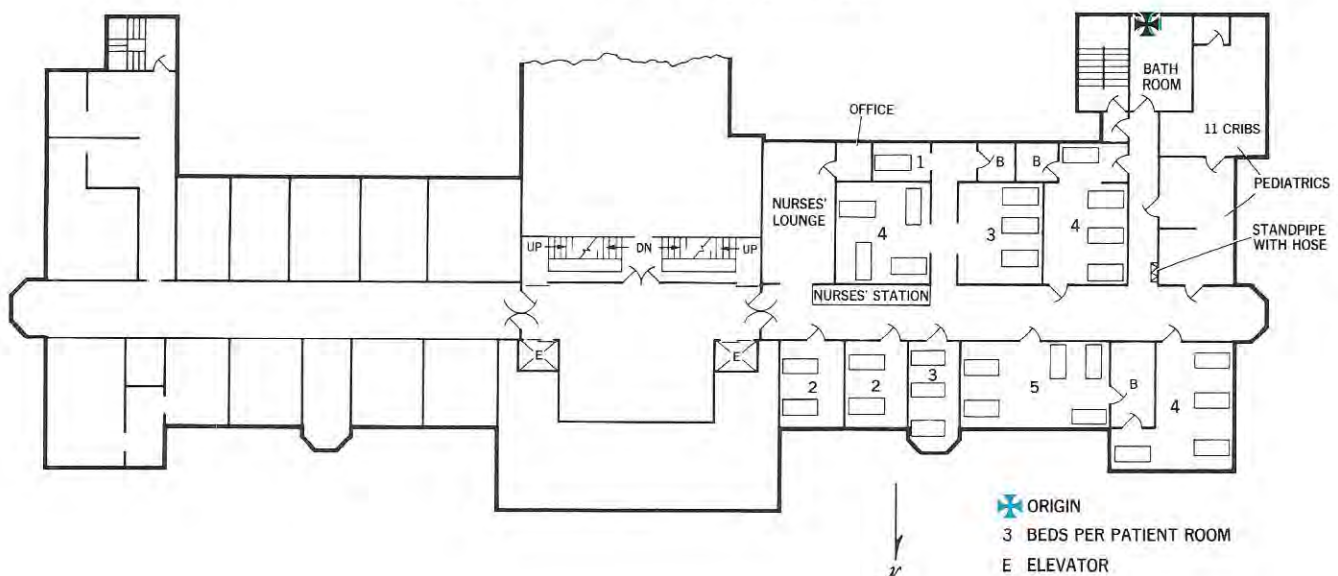
Figure 1. Second floor of St. Joseph's Hospital.

The original open, main, central stairway had been enclosed a number of years earlier with a wood and wire-glass partition. Although this partition would not have received any significant fire-resistance rating, it would have prevented smoke spread up the central stairway. The partition was arranged so that you could not travel the length of the stairway without entering each floor individually. In addition, there was an exit tower at the end of each wing (see Figure 1).

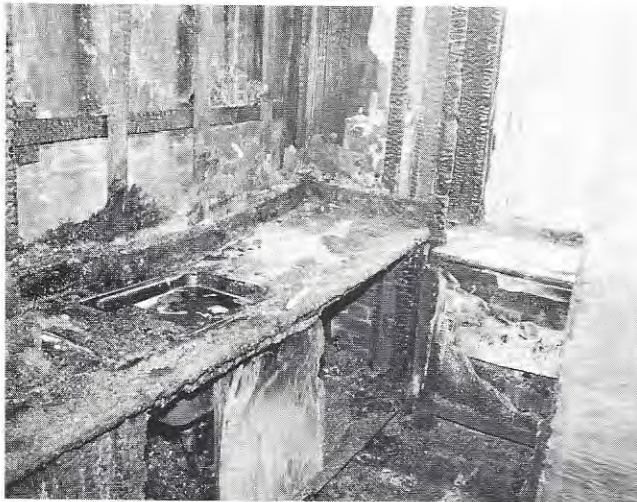
Area of fire origin in bathroom. Fire started under counter, between window and sink. NFPA

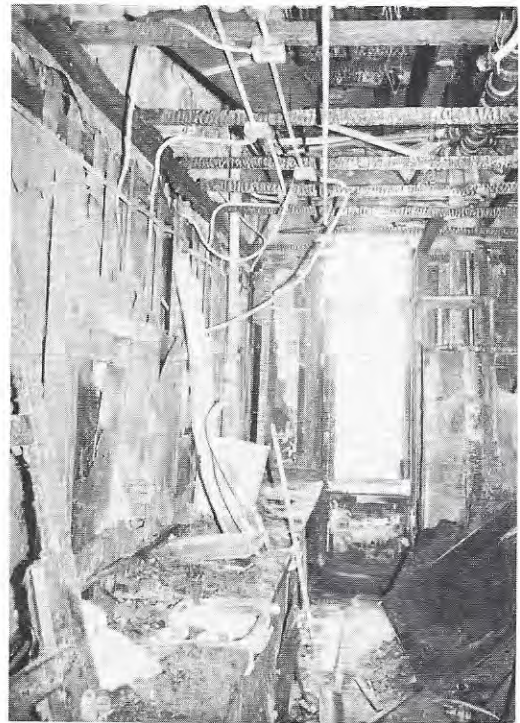
View of bathroom from north-south corridor. Area of origin is at far end of room at left of window. NFPA

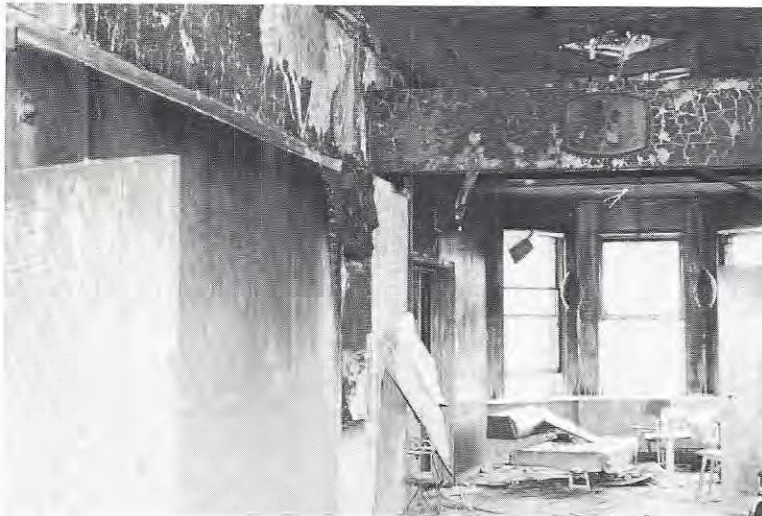
Looking west down main east-west corridor. Note damage where north-south corridor connects with the east-west corridor near left center of photo. NFPA

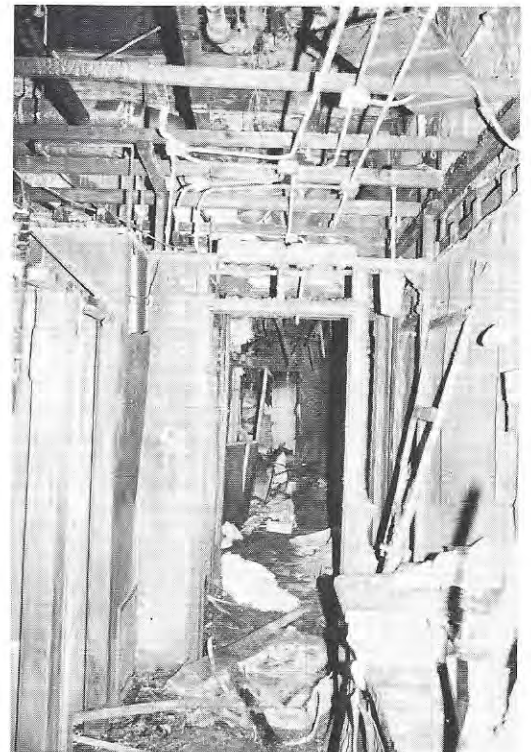
Looking north from area of origin down north-south corridor toward main corridor. Note the ceiling construction. NFPA
